Westminster Tornado

May 9, 2006 - 10:20 PM CST

Damage Assessment:

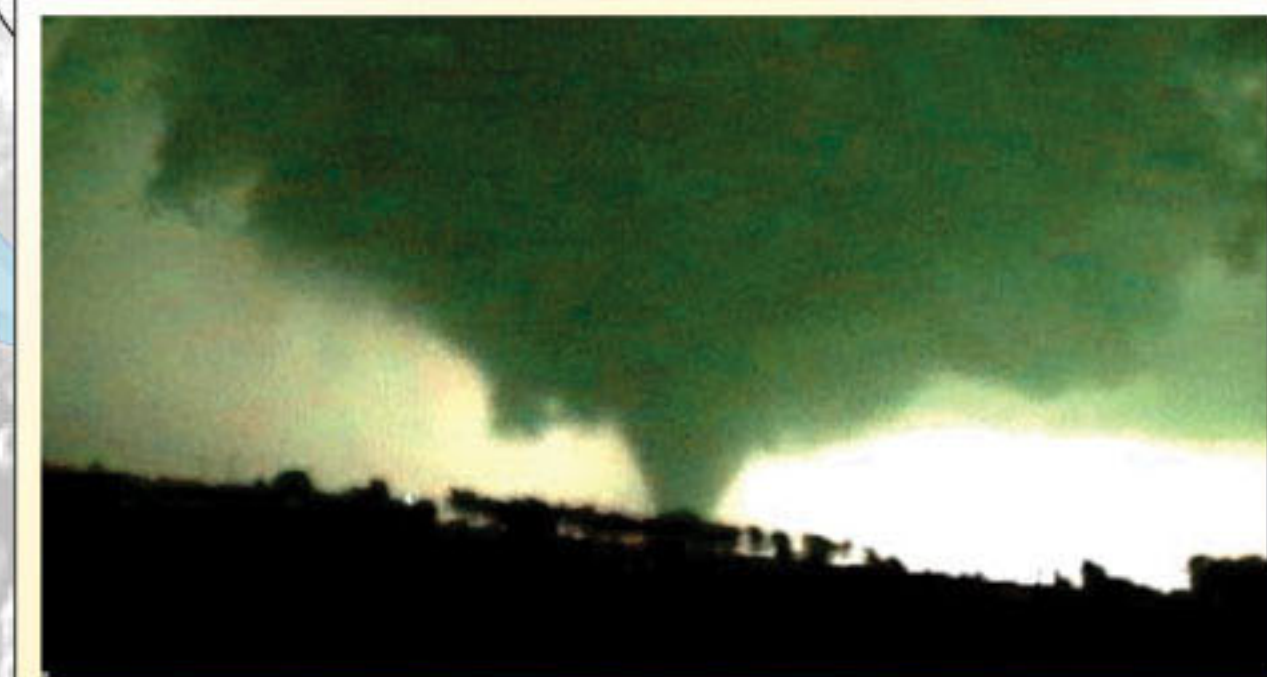
38 Total Structures Affected
7 buildings destroyed
9 buildings with "severe" damage
4 buildings with "moderate" damage
18 buildings "affected"

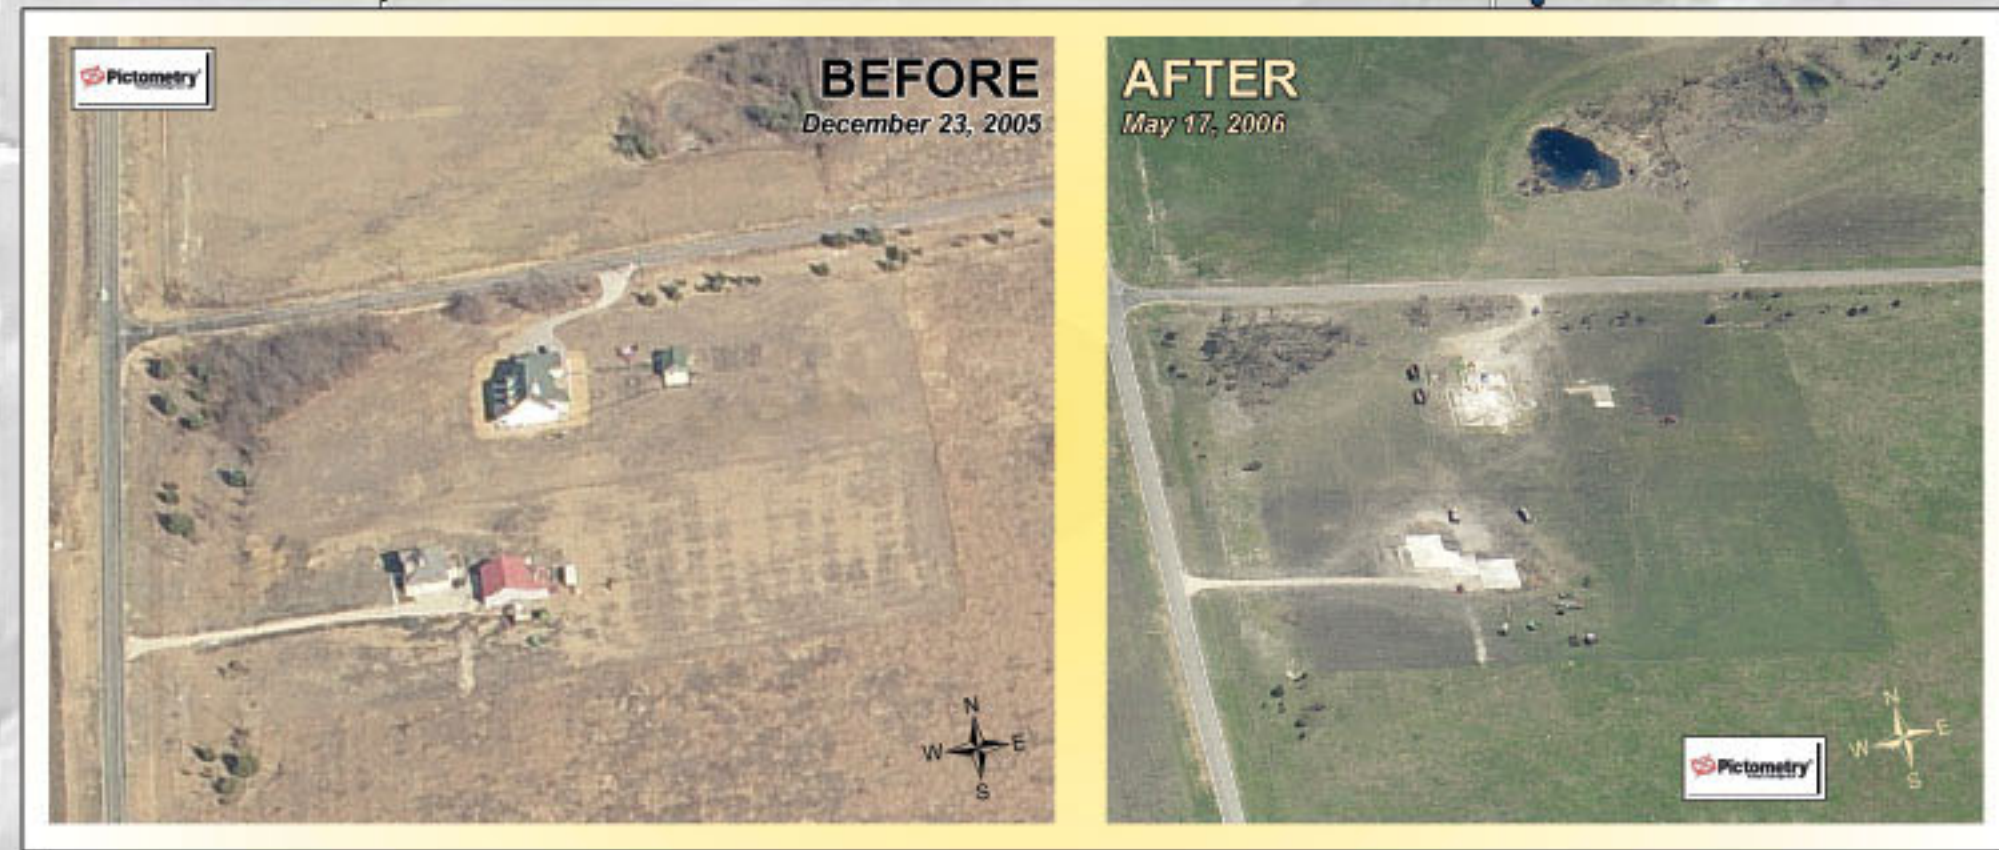
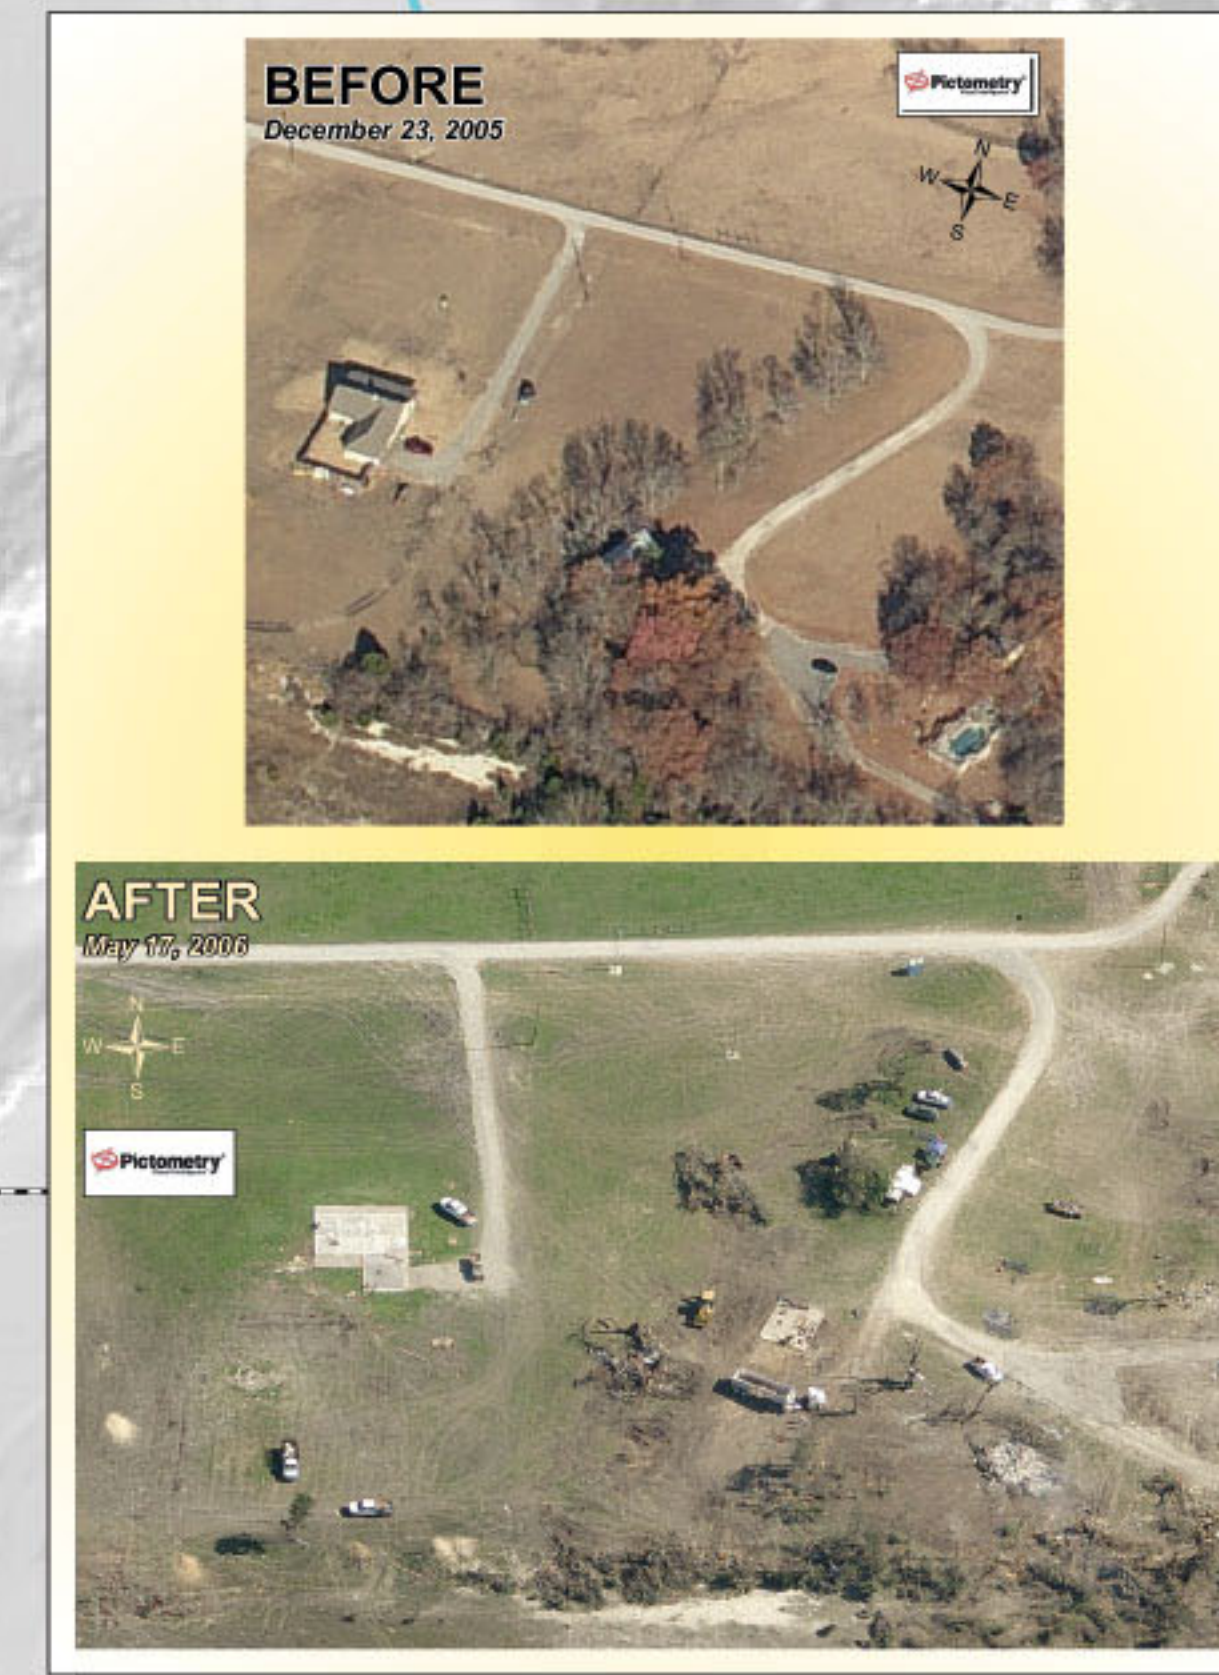
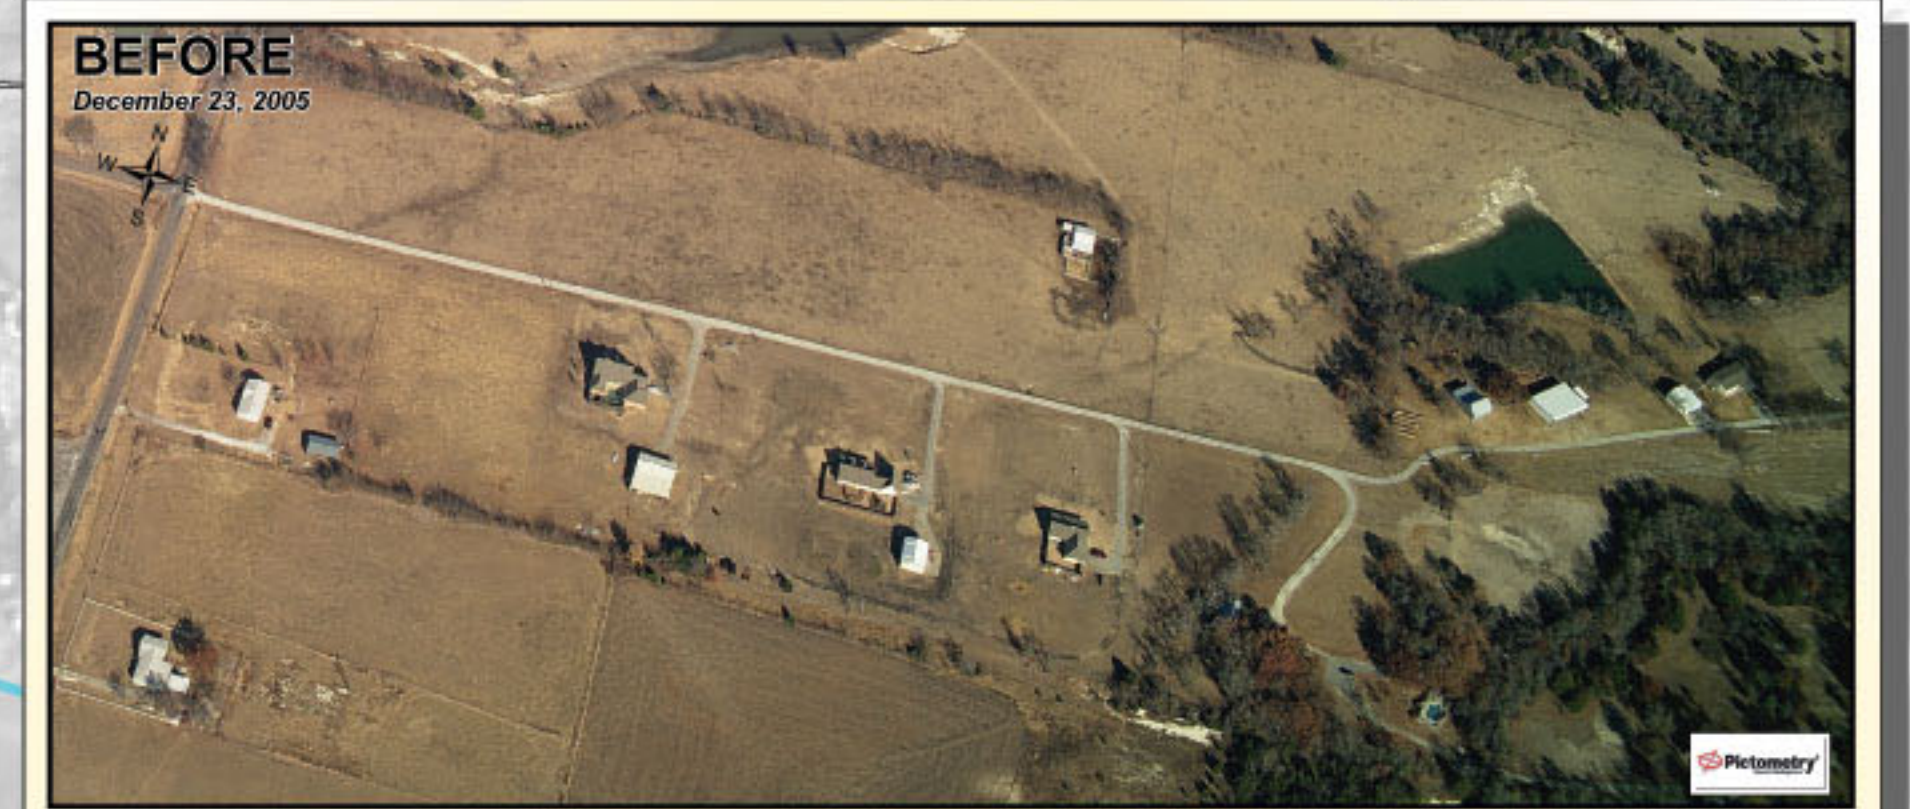
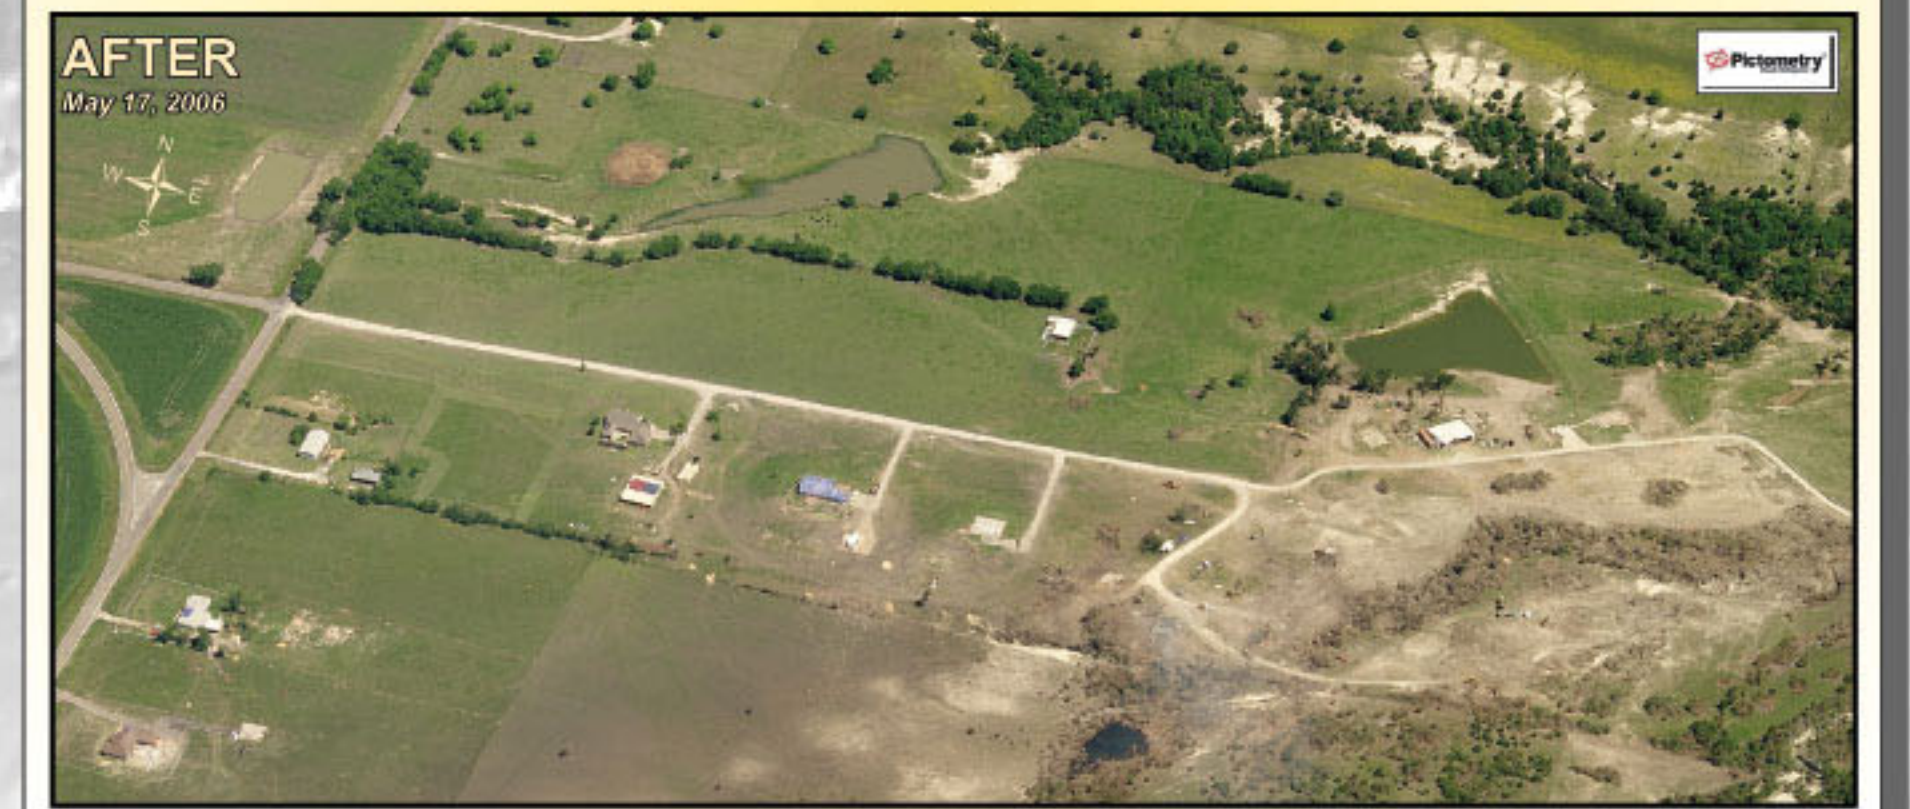
Devastation Path

Tornado path captured by a Dallas Morning News photographer the day after the event. This image shows the most destructive portion of the tornado. The view faces southwest from Grayson County to Collin County, Texas.

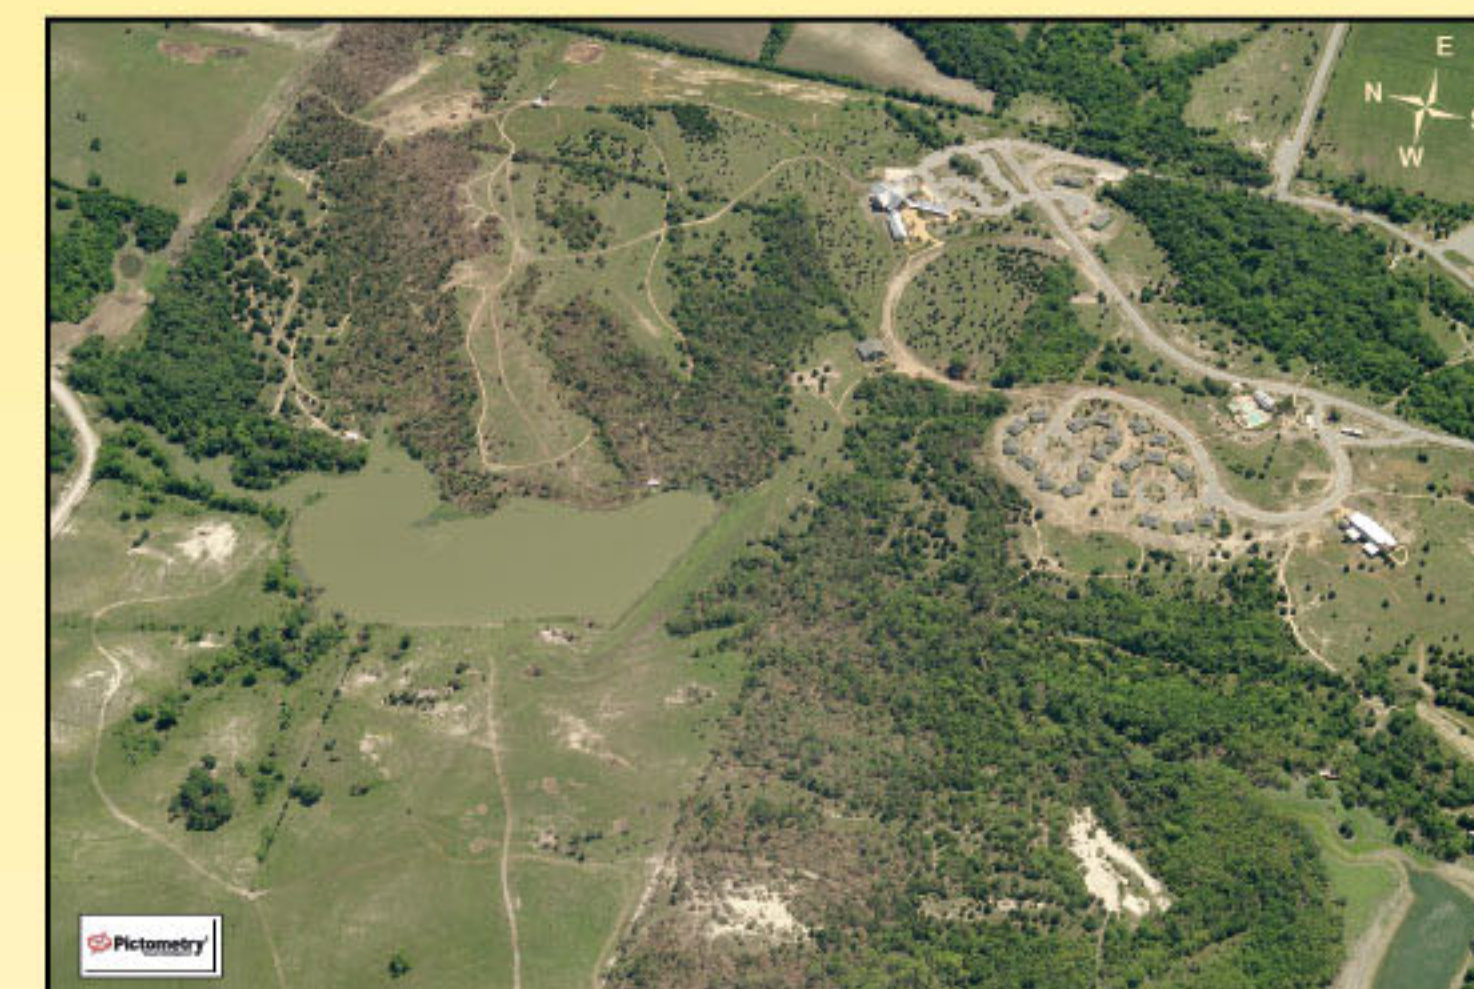
Close Call

The tornado ripped through the Collin County Adventure Camp a month before the camp opened. The Adventure Camp can have up to 500 visitors at any given time.

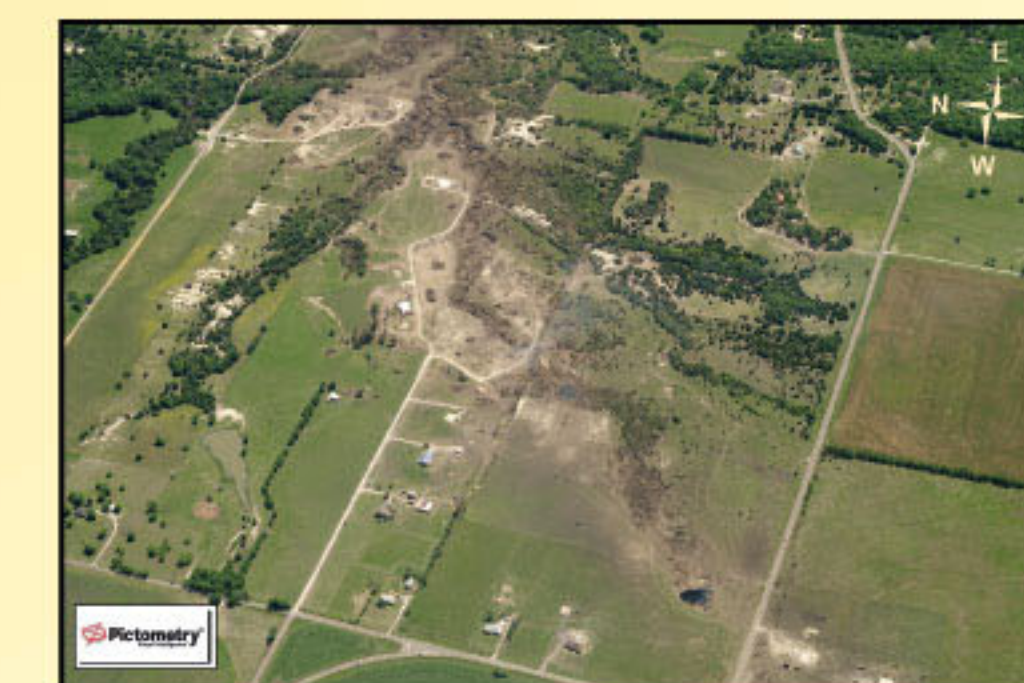
F3 Force

The Westminster Tornado was estimated to have F3 intensity with wind speeds between 156-206 miles per hour. This F3 tornado had enough power to scar the landscape.
